OPERATION
BREAKTHROUGH

U.S. Department of
Housing and Urban
Development

A COMPENDIUM
OF THE PERFORMANCE
TESTING PROGRAM

VOLUME

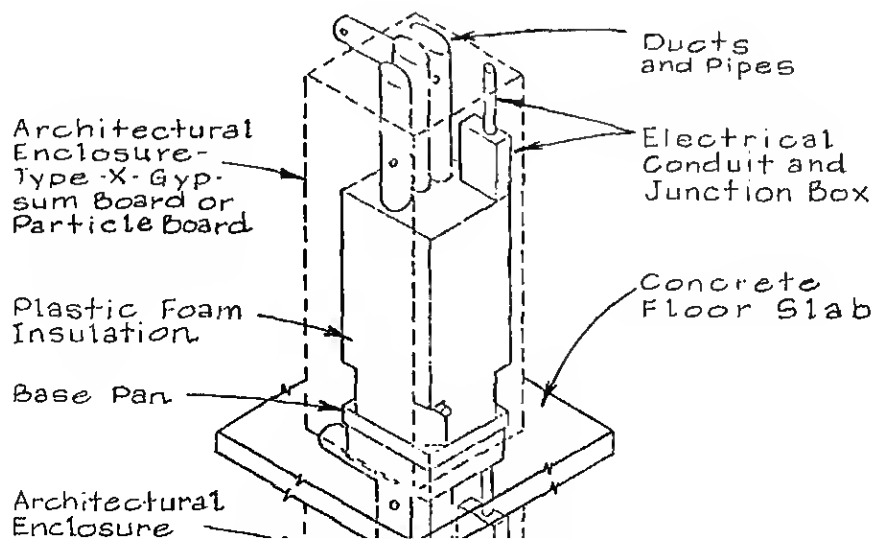
1. Passage of fire between floors through a mechanical/electrical core installed in a tall building. (See fig. 3.)

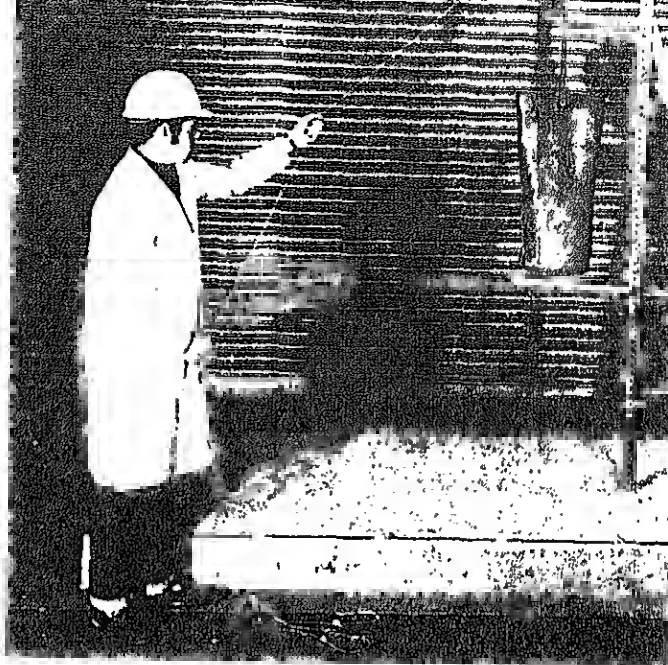
FIGURE 7
APPARATUS FOR APPLYING IMPACT LOADS TO WOOD JOIST FLOORS

consisted of impact loads (see fig. 7) of increasing magnitude alternating with static loads of a fixed magnitude being applied to the test specimens. Deflection measurements indicated that the deflection caused by a given concentrated load increases as the impact energy previously applied to the floor increases.

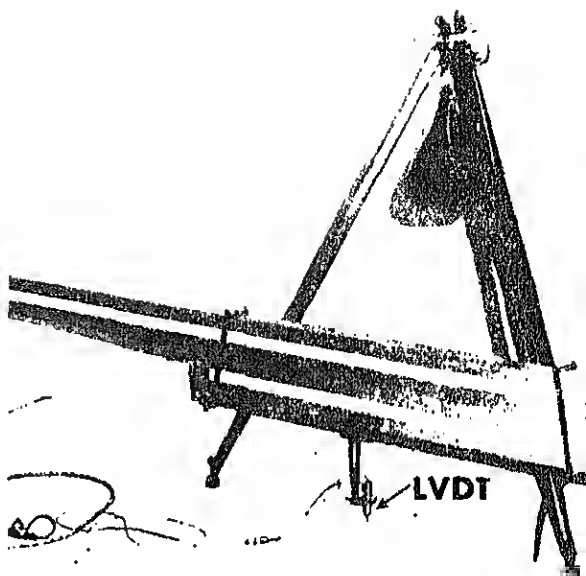
FIGURE 9
APPARATUS FOR
INDUCING TRANSIENT VIBRATIONS

Testing was carried out in a total of 34 rooms in seven completed prototype dwelling units—four furnished and three unfurnished. A load was applied by drop-

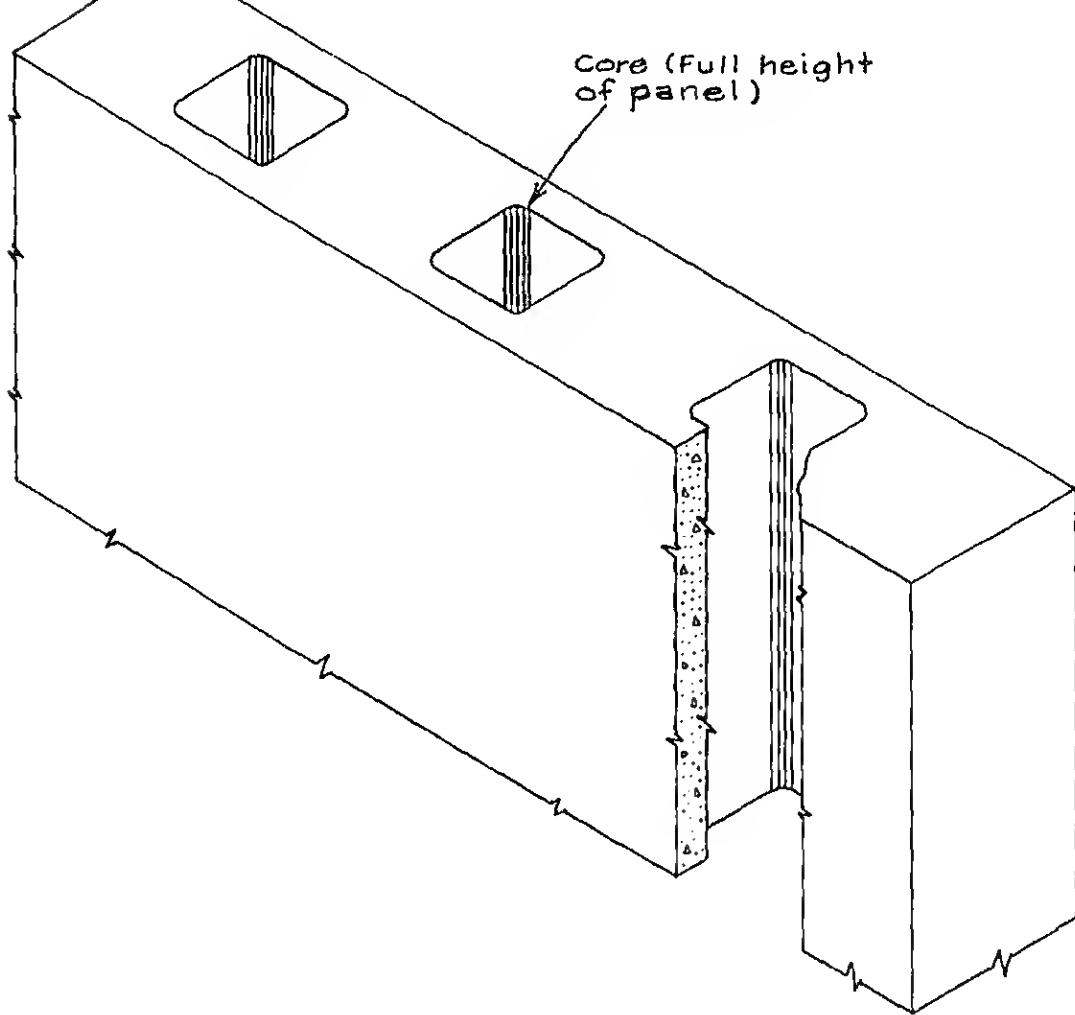
FIGURE 11
HOLLOW CORE PRECAST WALL PANEL USED IN CONCRETE BUILDING SYSTEM

One of the Operation BREAKTHROUGH systems used hollow core precast concrete wall panels. When these were erected they served as supports for thin prestressed concrete slabs. The slabs in turn served as a form for

cast in place concrete topping to produce a composite floor or roof. Depending on conditions, some or all of the wall panel cores were filled with cast in place concrete.

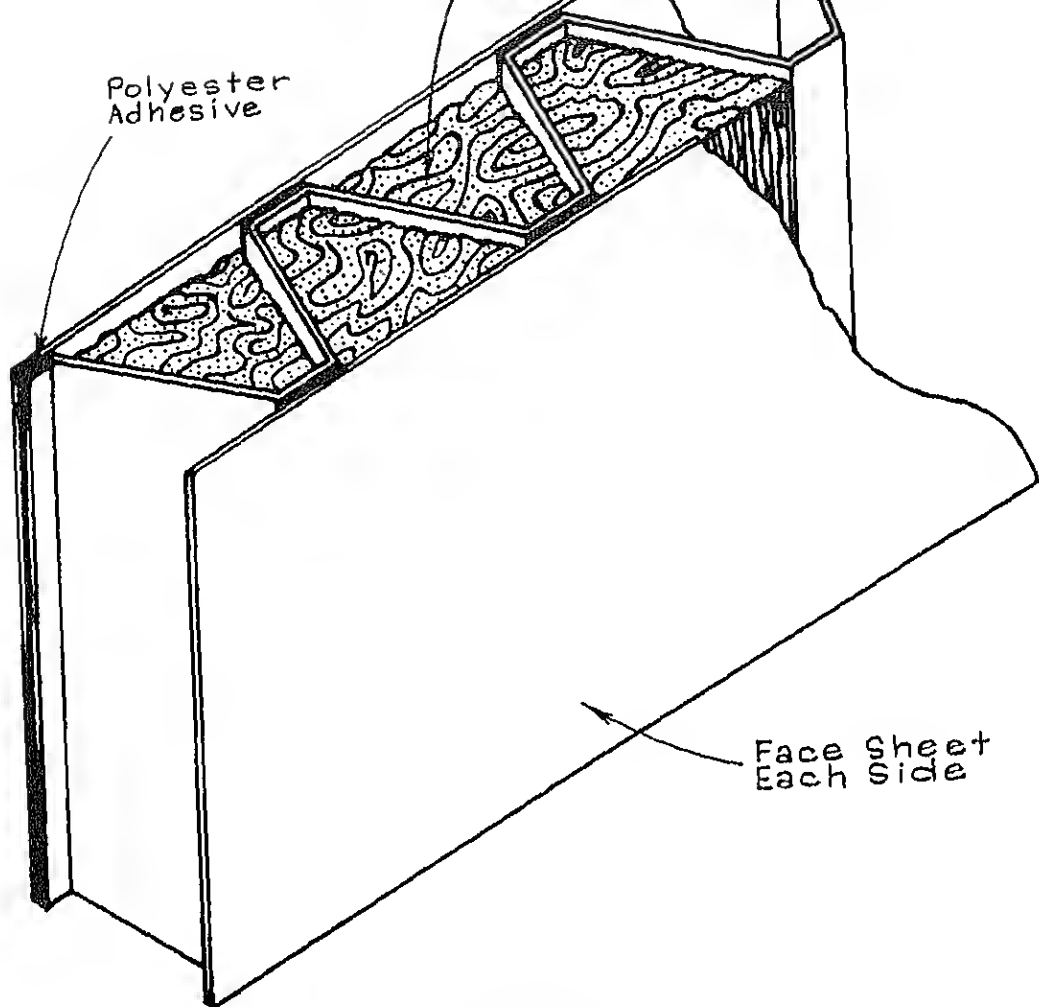
FIGURE 13
FIBERGLASS REINFORCED POLYESTER SANDWICH PANEL

An innovative structural system employed by one Operation BREAKTHROUGH HSP used a plastic laminate assembly in walls, roofs, and interior partitions. The basic

The innovative panel described in section 3.3.2 and shown in figure 13 also required testing to determine its structural properties. The sheets themselves were an innovative building material, the strength of the adhesive joining them had to be evaluated (some study of this was made in the tests reported in section 3.3.1), and the behavior of the assembly, while it could be calculated, had to be verified experimentally. The effects of moisture and temperature on the behavior of the panel material also required investigation. This test program was undertaken to study all these features.

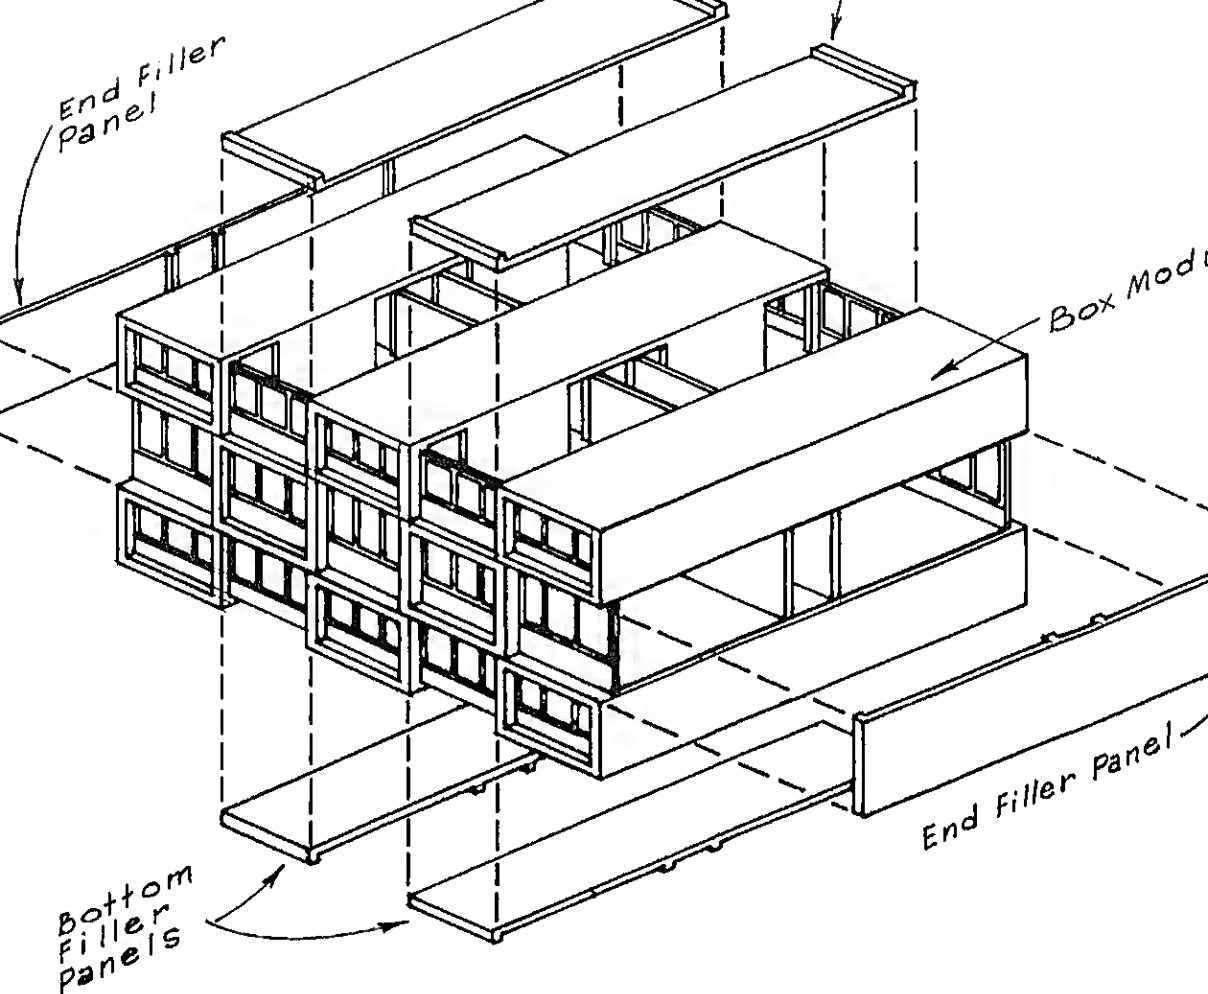
FIGURE 14
ASSEMBLY OF PRECAST UNITS IN CONCRETE MODULAR HOUSING SYSTEM

Innovative construction details require special consideration particularly when they involve materials whose properties are not well known or whose interaction has not been investigated. This program was carried out to study the behavior and strength of a column connection system used between prefabricated housing modules.

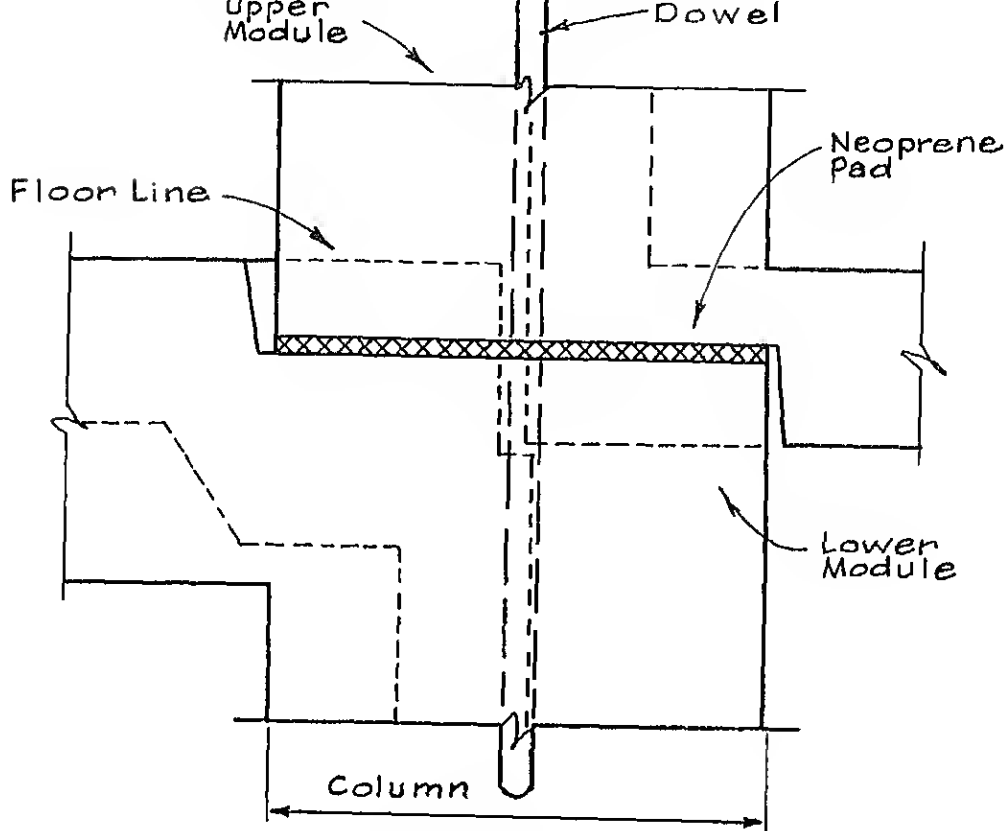
FIGURE 15
DETAIL OF COLUMN CONNECTION IN PRECAST CONCRETE BOX HOUSING SYSTEM

transmitted from the columns of one module to those of the module immediately below through neoprene pads. Compressive bearing stresses were considerably higher than those normally used with neoprene. Resistance to any uplift and also to horizontal shear was provided by a grouted dowel crossing the horizontal joint. (See fig. 15.)

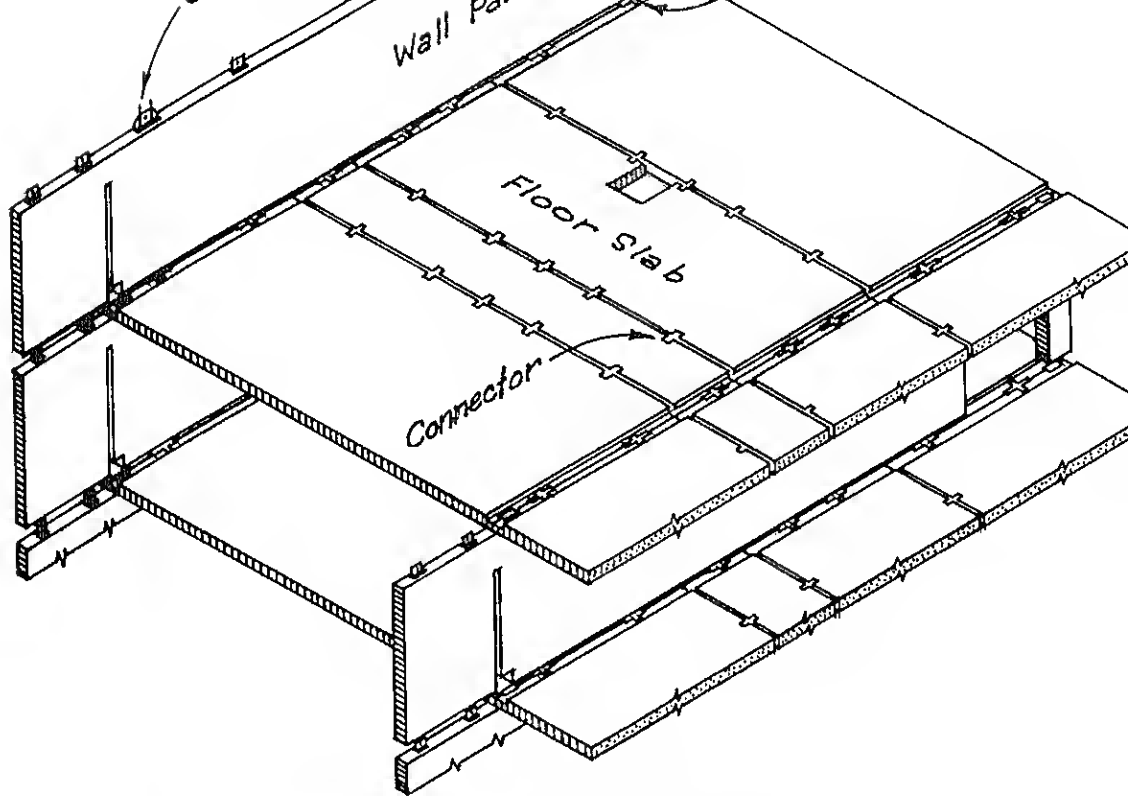
FIGURE 20
ASSEMBLY OF UNITS IN PRECAST CONCRETE PANEL HOUSING SYSTEM

One Operation BREAKTHROUGH system to which this applied used large precast concrete wall, floor, and roof panels with bolted steel interpanel connecting elements. These elements were very important because they furnished the primary structural connection between the panels and were designed not only for the transfer of static loads but also of wind and seismic loads that were to be carried through the floor diaphragms to shear walls. (See fig. 20.) Since there was no standard test for the features to be investigated, methods were devised to simulate the loadings for which the system was designed. Small sections of finished, full size concrete elements were used as test specimens during simulated loading. Electronic instrumentation was used to measure and record loads and deformations.

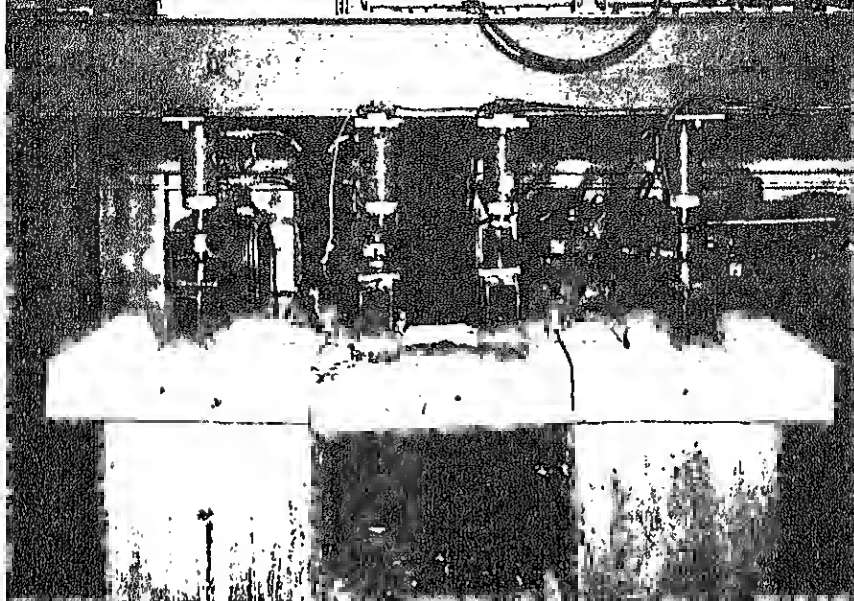
FIGURE 24
TESTING HOUSING SYSTEM INSERT SHOWN IN FIG. 23 (VERTICAL SHEAR)

The first test, on the Type B element, measured tensile pull out resistance by a method similar to that used with Type A connections. Vertical (out of plane) shear tests were conducted on specimens constructed to represent portions of three side by side slabs joined at their edges by Type B connectors. The center slab was pushed down while the others were restrained. (See fig. 24.) Similar specimens were used for investigation of horizontal (in plane) shear resistance. They were tested with the slabs in a vertical plane; the outer slabs were supported near the juncture with the center slab so as to minimize rotation and produce as closely as possible a pure shear loading condition. (See fig. 25.) When the center slab was pushed down, the vertical force was resisted by friction at the interfaces until slip occurred. Ultimate failure during this

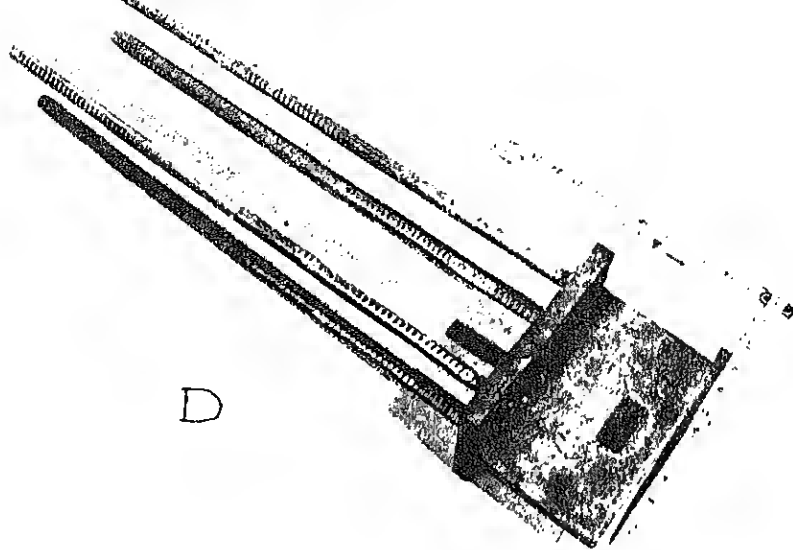
FIGURE 26
TYPE D INSERT USED IN A CONCRETE HOUSING SYSTEM

Type D wall connectors (see fig. 26) were used, in conjunction with Type A, to join floor slabs and bearing walls. Because of the Guide Criteria recommendations for prevention of progressive collapse, the ability of the Type D connectors to resist shear forces acting perpendicular to the face of the wall was critical. The test specimen for the Type D element was in the form of an H, with the wall panel as the crossbar. Concrete members representing the floor slabs formed the verticals. Load was applied to the wall near the face of the slabs. Failure occurred when the connection started to shear through the concrete.

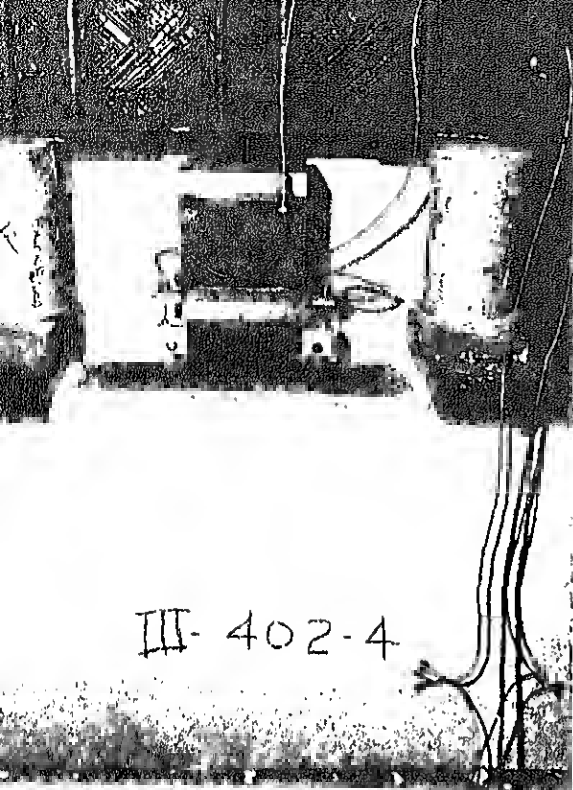
FIGURE 28
TESTING TYPE E INSERT
USED IN CONCRETE HOUSING SYSTEM

load was applied to the bolts at the top of the connector (see fig. 28), whereas in testing the Type F connector, the load was applied to bolts simulating those from a Type E connector. (See fig. 29.) Failure occurred either by breaking the bolts or stripping the threads.

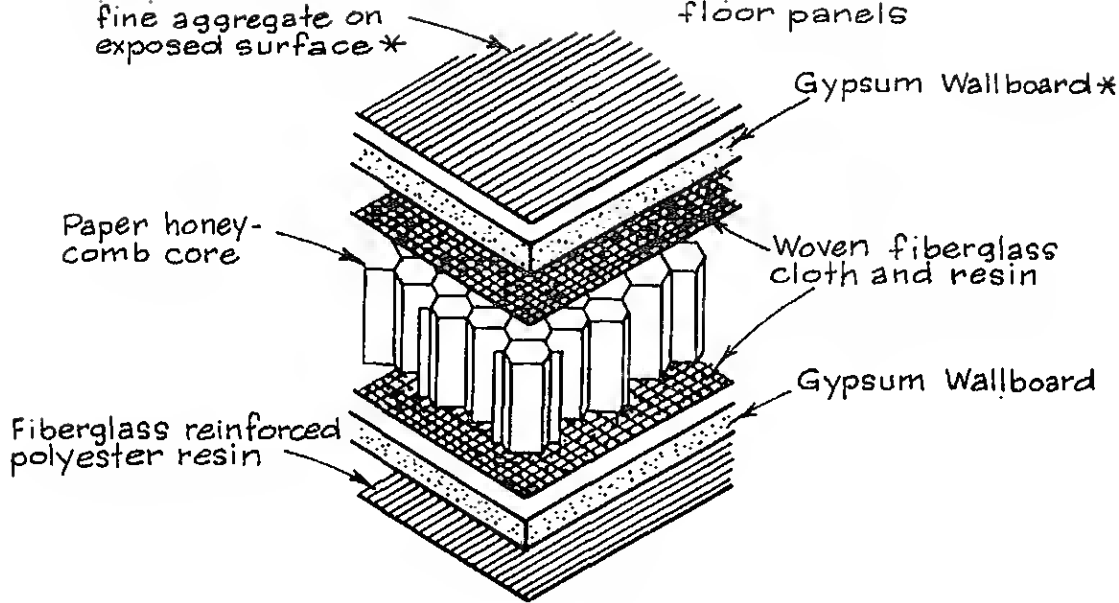
FIGURE 32
HONEYCOMB CORE PANEL WITH GYPSUM WALLBOARD FACING

One of the Operation BREAKTHROUGH systems employed innovative panels consisting of paper honeycomb cores faced with fiberglass cloth reinforced polyester resin for roof, wall, and floor members. This sandwich was the basic structural element for the entire housing unit. Both faces, except for floor panels, were covered with gypsum wallboard for physical and fire protection. Plywood was used as the upper (walking) surface of floor panels in place of gypsum board. Exposed surfaces of exterior wall panels were protected with

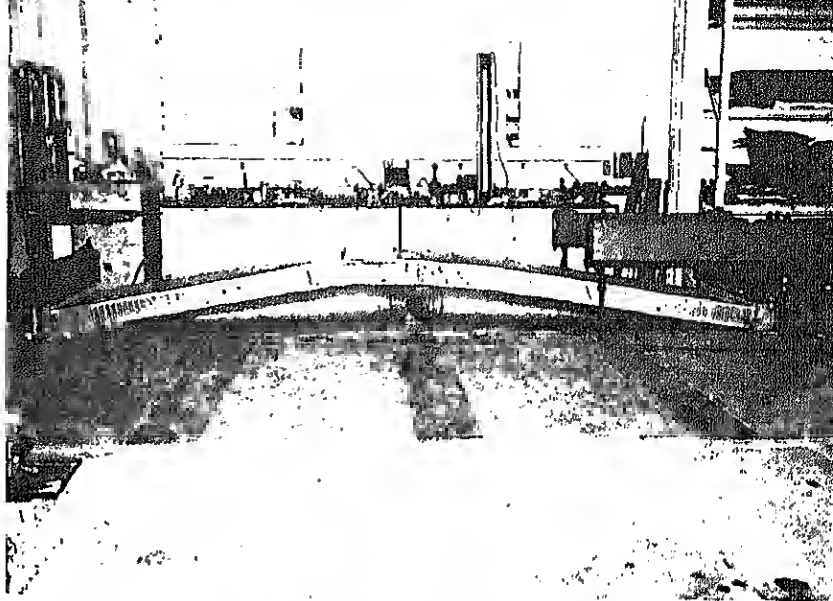
FIGURE 33
PANEL FLEXURE TEST
(IN INVERTED POSITION)

(See fig. 33.) Deflections were measured and recorded throughout the test. Results of this test showed that the ultimate capacity of the panels was about three times the service load, and that the behavior in flexure was quite elastic.

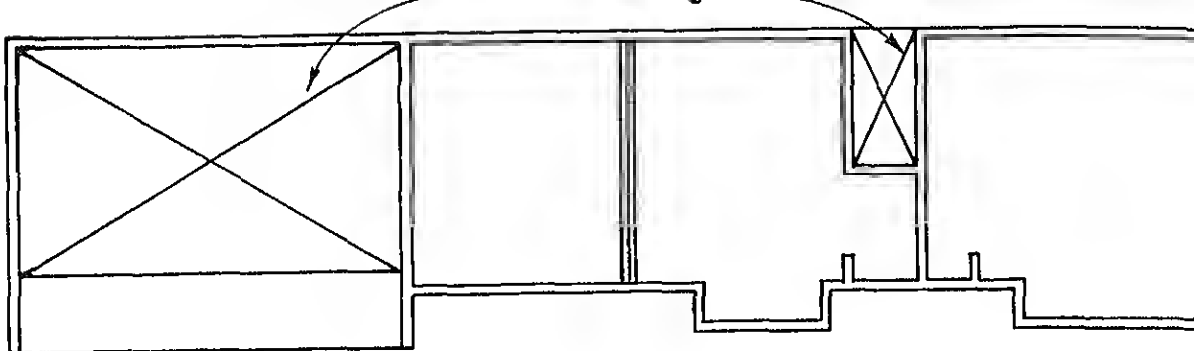
FIGURE 45
FLOOR PLAN OF MODULE TEST ASSEMBLY SHOWN IN FIG. 44

The module chosen for study was part of a building system in many ways similar to conventional construction with wood joists, studs, rafters, sills, plates, plywood roofs and floors, gypsum board wall surfaces, etc. (An extended description can be found in Reference 36.) The test module formed the upper story of the front section of a row housing cluster constructed from several similar modules. (See fig. 44.) The left hand portion of the module was triangular in cross section, served as the

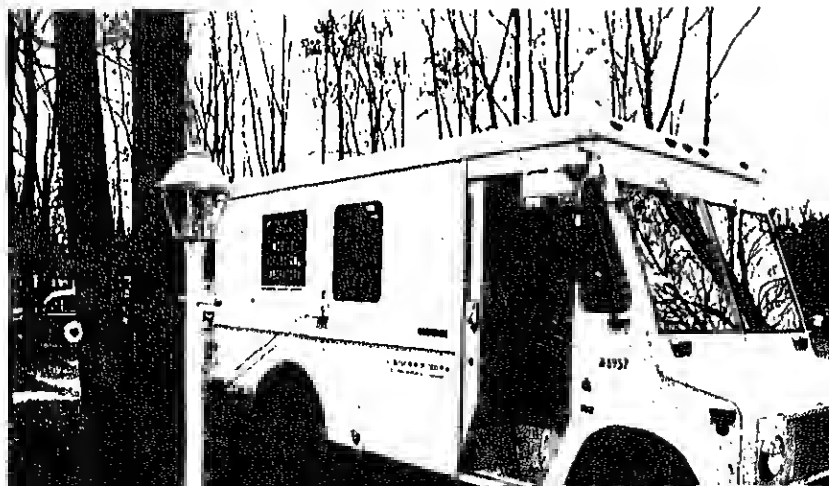
FIGURE 56
MOBILE ACOUSTIC
TEST LABORATORY

have a significant effect on actual acoustic performance. For this reason a series of field studies was undertaken to measure inter-dwelling and intra-dwelling noise isolation in several Operational BREAK-THROUGH housing systems and to assemble data that would be useful in making a comparison with conventional housing. An on-site mobile acoustical laboratory was used to make impact and sound transmission measurements in accordance with the procedures given in ASTM E 336, ASTM E 413, ASTM RM 14-4 [51], ASTM C 423 [52], and American Standards Institute (ANSI) S1.2. [53]. (See fig. 56.)
